WAR DEPARTMENT
 U. S. ARMY AIR FORCES
 REPORT OF AIRCRAFT ACCIDENT

(1) Place 12 Miles South of Beaman Field, Ky. (2) Date June 4, 1943 (3) Time 3000GAT
 AIRCRAFT: (4) Type and model UC-78 (5) A. F. No. 42-71738 (6) Station Freeman Field, Indiana
 Organization: (7) SEAFIC (8) _____ (9) _____ (10) 147th Base Sq. AAF Base Sq.
 (Common Land Air Force) (Group)

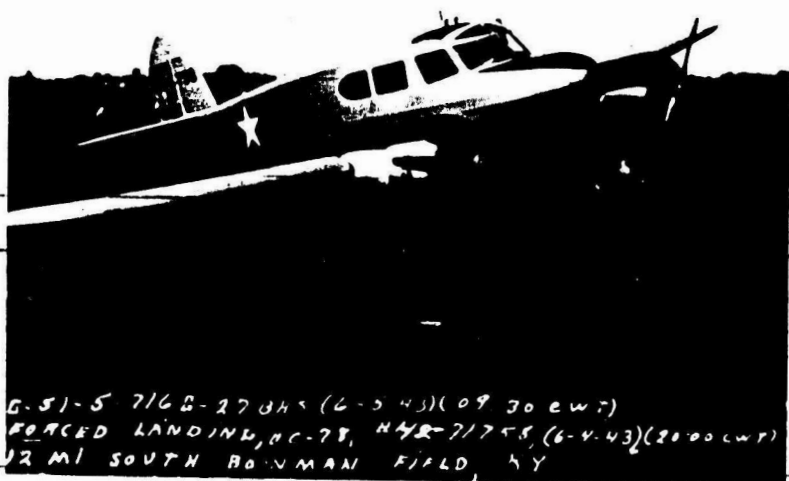
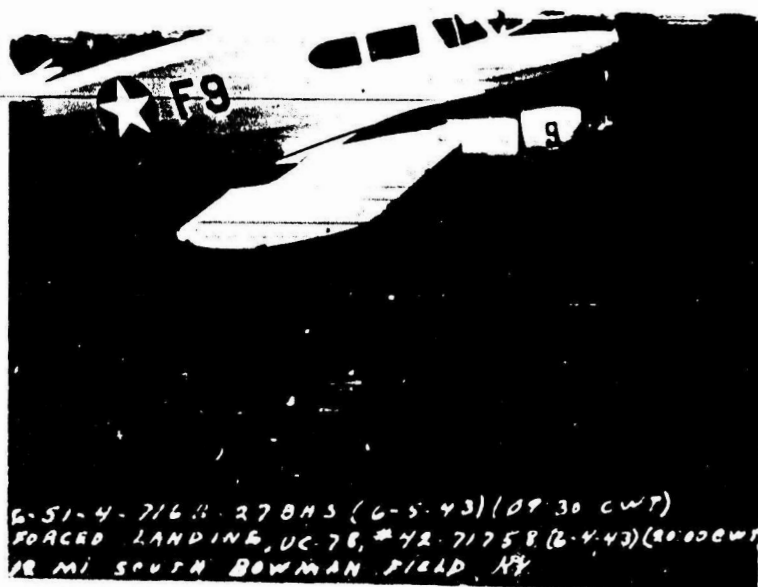
The pilot selected a good field at approximately 2000 OWT down grade slightly, landed into the wind and rolled approximately 900 feet, struck a fence and stopped approximately 75 feet beyond the fence. The right landing gear collapsed and damage was done to the right wing.
