WAR DEPARTMENT
U. S. ARMY AIR FORCES
REPORT OF AIRCRAFT ACCIDENT

(1) Place Millport, Koehn, Indiana (2) Date 19 October 1943 (3) Time 1720Z
AIRCRAFT: (4) Type and model AT-10 BE (5) A. F. No. 41-27328 (6) Station Freeman Army Air Field
Organization: (7) AAAFPTC (8) 30th Wing (9) 1079th TRFS
(Command and Air Force) (Group) (Squadron)

Accident No. 44-10-19-9

DESCRIPTION OF ACCIDENT

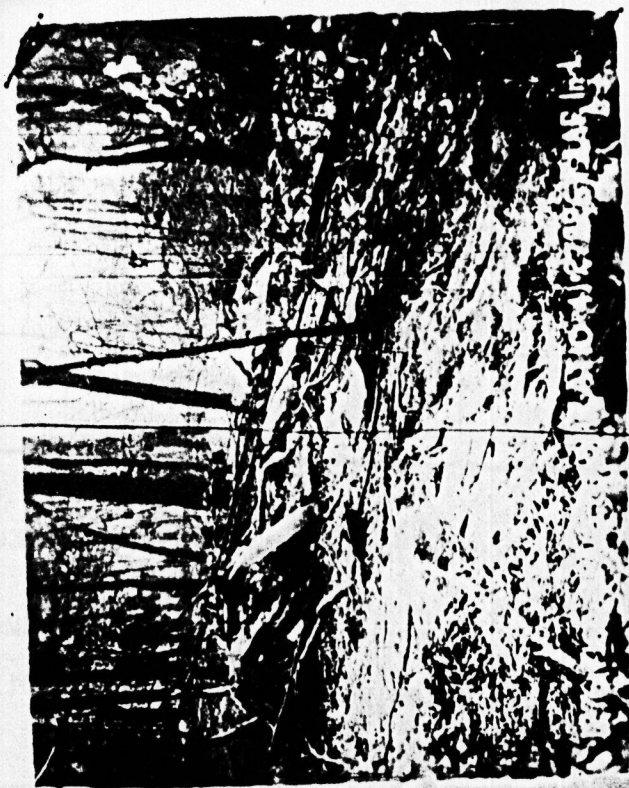
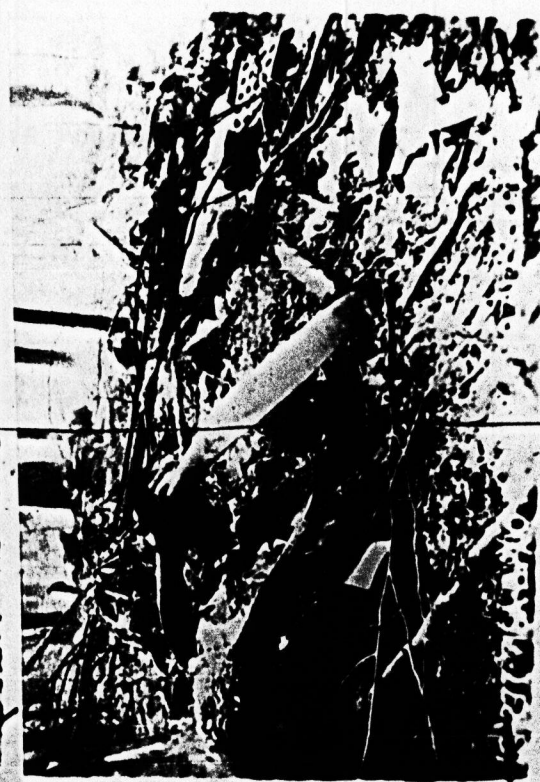
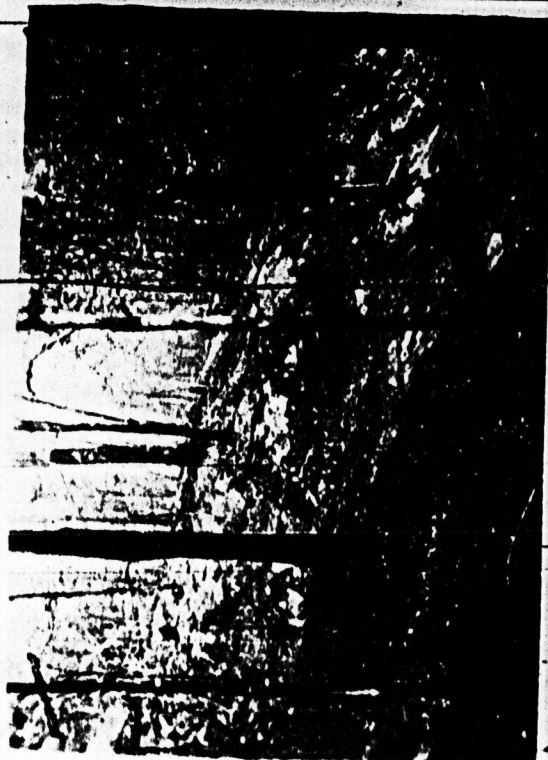
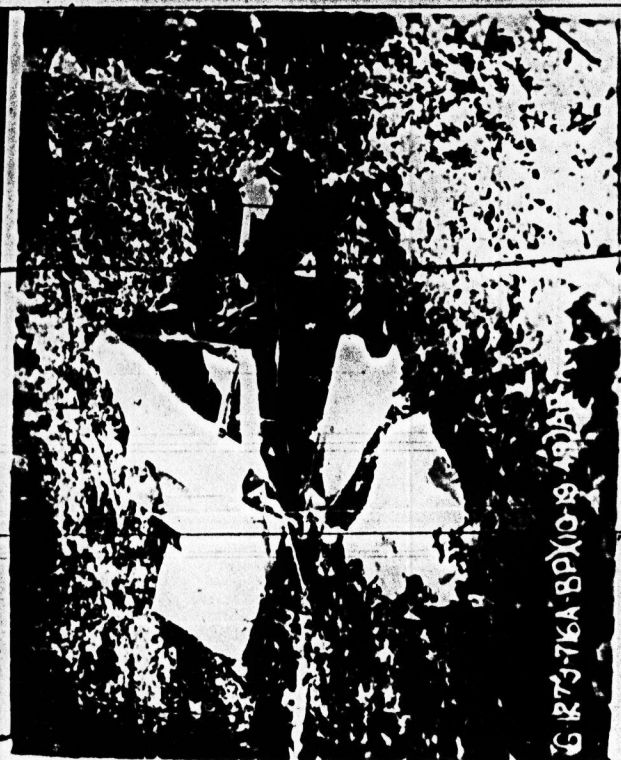
The airplane struck the ground and immediately burst into flames causing fatal injuries to Campbell, K. (NMI), A/C, the co-pilot. Cadet Breen's parachute opened successfully and he stated that he hit the ground very shortly after his parachute had opened. The parachute was found within 100 feet of the wrecked airplane which was a complete wash-out.

The cause of the accident was structural failure due to excessive high speeds beyond the limits of the airplane. All flying personnel at this station have been cautioned to know their airplane and not to exceed any of its limitations.

<u>QUANTITY</u>	<u>UNIT</u>	<u>PART NO.</u>	<u>DESCRIPTION</u>	<u>STATUS</u>
			Airplane burned after crashing, resulting in total loss of airplane.
