WAR DEPARTMENT
U. S. ARMY AIR FORCES

REPORT OF AIRCRAFT ACCIDENT

(1) Place St. Anna Field, Aux. of Freeman Fld. (2) Date 22 February 1944 (3) Time 2715Z
 AIRCRAFT: (4) Type and model T-10-BH 091 (5) A. F. No. 41-27296 (6) Station Freeman Field
 Organization: (7) AAFTTC (8) 30th Wing (9) 1079th TFS
 (Command and Air Force) (Group) (Squadron)
ET-7 PERSONNEL AFT AFT 5173

DESCRIPTION OF ACCIDENT

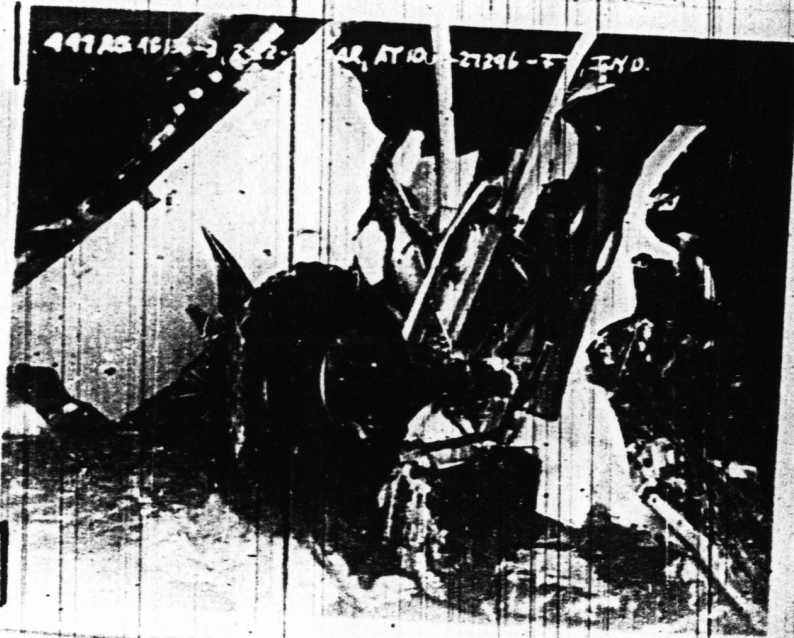
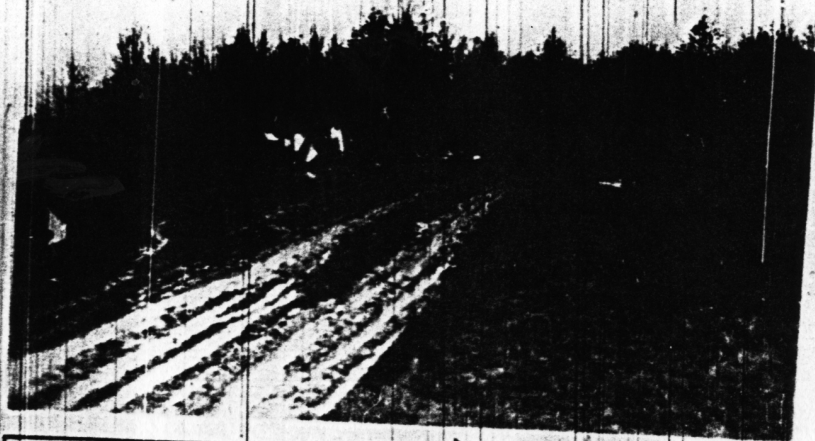
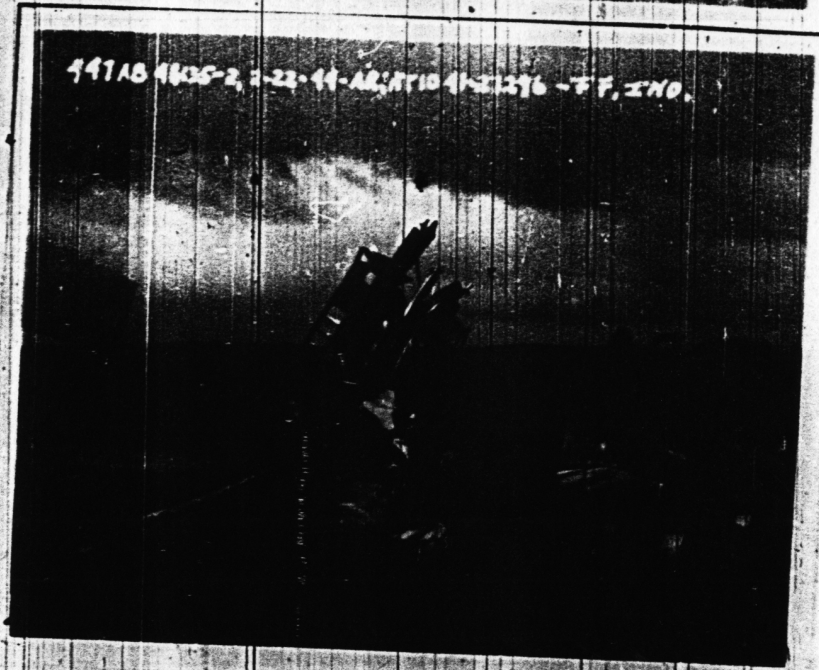
1. Aircraft AT-10BH, Army Air Forces serial number 41-27296 damaged in accident on 22 February 1944, was found to have the following damage.

Airplane	100%
Radio Equipment	100%
Engines	100%
Propeller Assemblies	100%
Instruments	100%
Furnishings	100%

NOTE: Airplane crashed and burned.

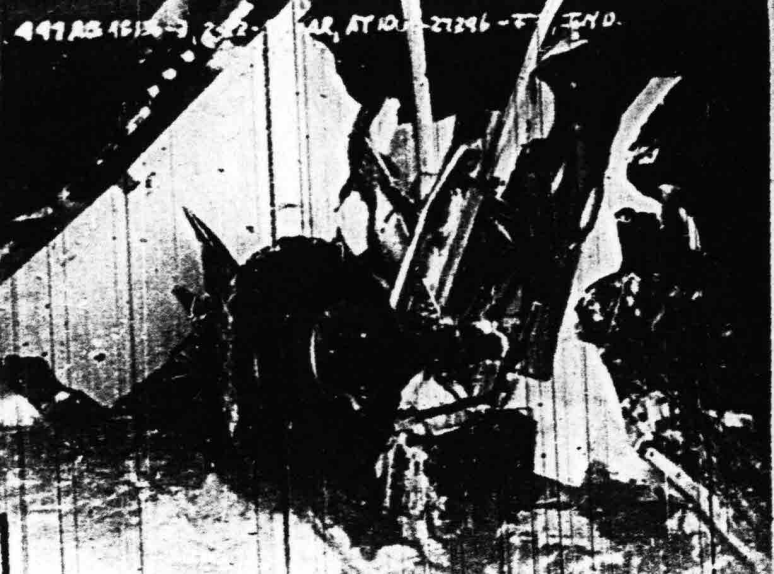
497 AS 1613-3, 232- AR, AT 10, 27296 - F, FND.

Upon investigating the accident, it was found that the airplane had struck the ground in a vertical position and that both occupants were dead.
